# YOU CAN DO IT EASY UPGRADES

## 1ST GEN TECH: SUBFRAME BUSHING REPLACEMENT

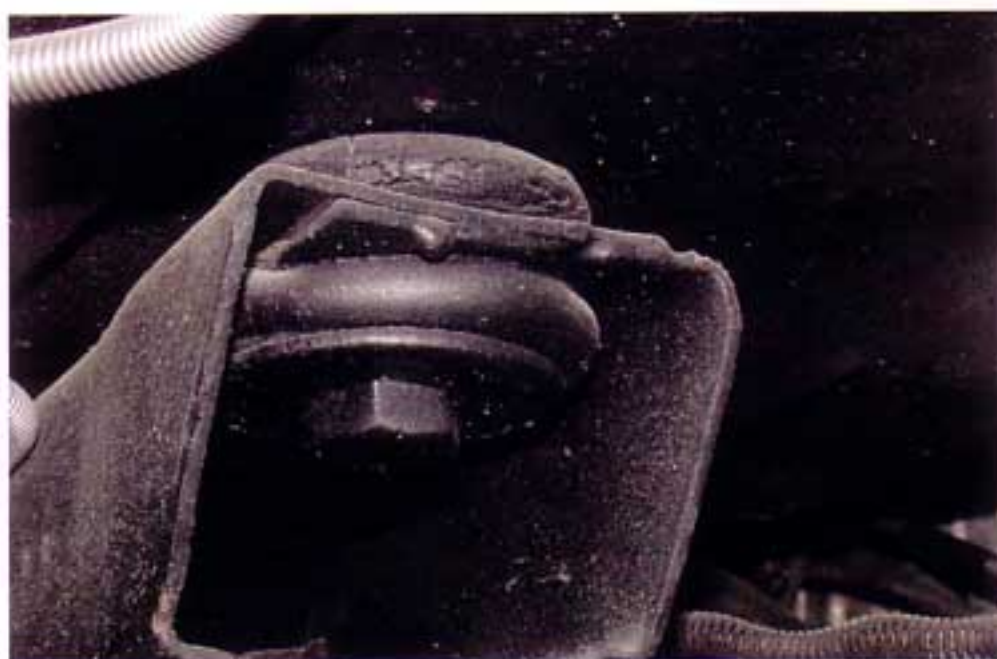
**Photo #1:** Cracked and dry-rotted bushings indicate it's time to replace them.
