# YOU CAN DO IT EASY UPGRADES

## 1ST GEN TECH: SUBFRAME BUSHING REPLACEMENT

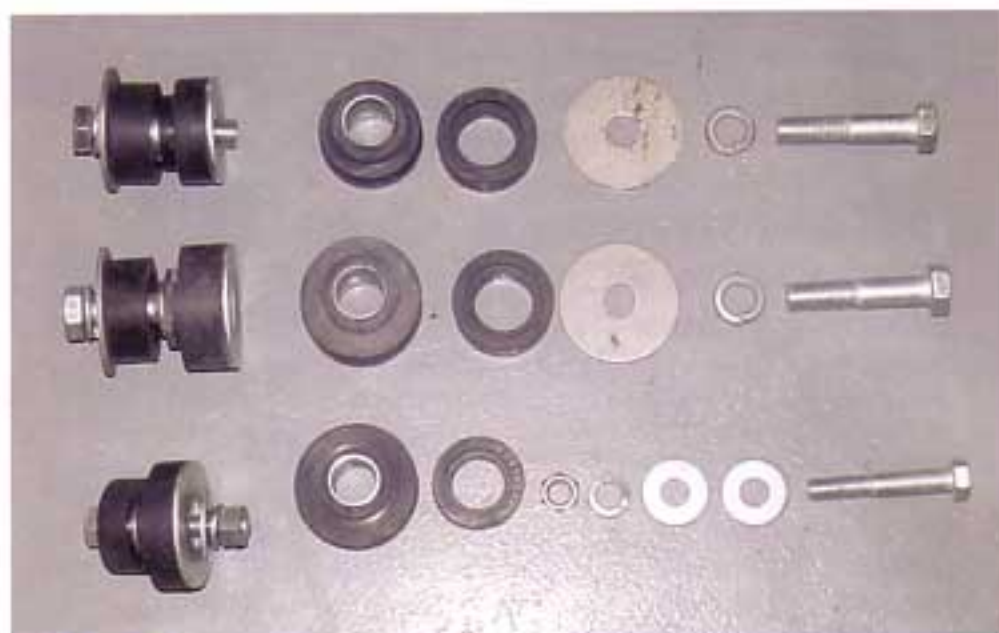
**Photo #2:** Shows the bushings and hardware items necessary to restore your subframe. Proper orientation of these bushings can be found in the Camaro assembly manual.

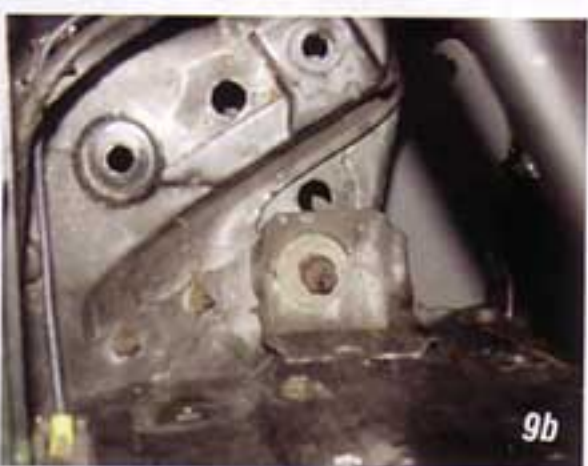
**Photo #9a & 9b:** The passenger side of the car is done much the same manner, with the exception of removing the battery and the battery tray to gain access to the core support bolt.
